**PICKETT PARK HOMEOWNERS'
ASSOCIATION, INC.**

DURHAM, NC

JANUARY 30, 2023

FULL RESERVE STUDY

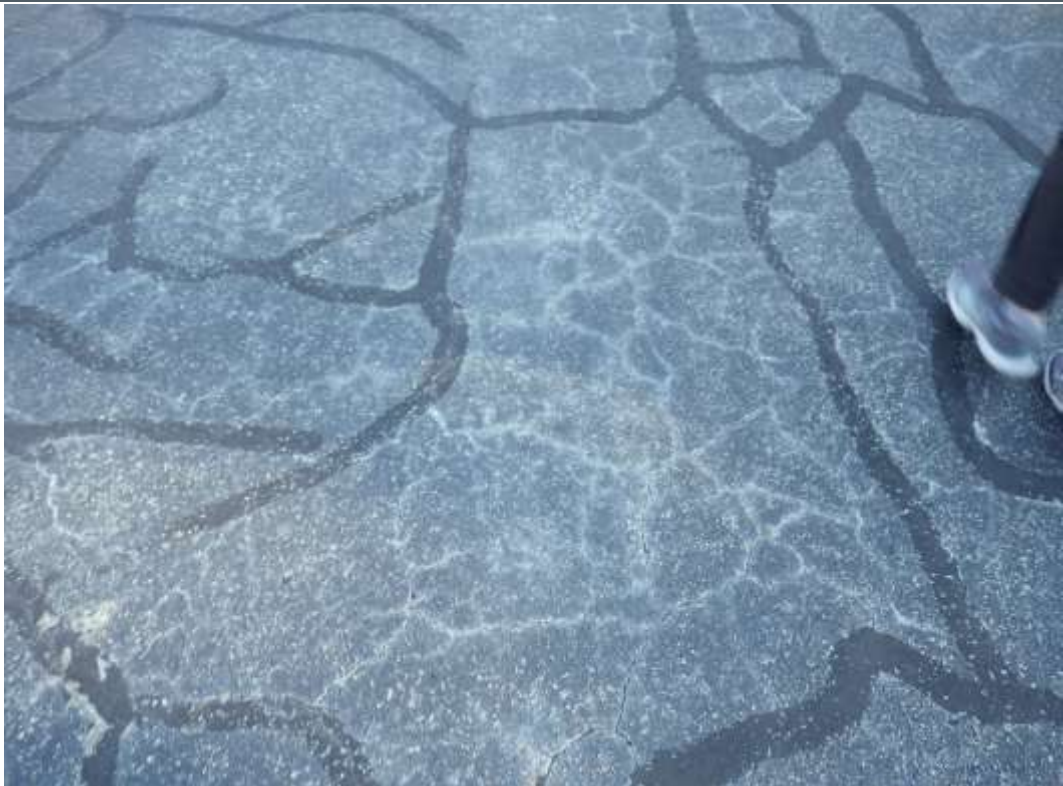
The fatigue cracking is symptomatic of a failure in the base course/subgrade material. Over time, as this condition advances, subgrade failure can result in expanding fatigue cracking, depressions and potholes. This type of failure typically requires full-depth patch repairs, which would involve saw-cutting and removing damaged areas of paving, repairing the subgrade as needed and installing a new asphalt patch to match the surrounding pavement. This can be performed as a standalone repair, or in combination with overall pavement resurfacing.

Fatigue cracking in northern portion of private street	
Photo No. 6

Per request from the Board, we have included funds to resurface all of the pavement in 2028. Resurfacing would include milling limited areas around curb and gutter to maintain an adequate drainage profile, full-depth repairs to the areas fatigue cracking/upheaval, and installing a new 1.5” to 2” thick layer of asphalt pavement over all of the existing paved areas. This project has been deferred to 2028 in favor of higher priority capital repairs discussed later in this report.

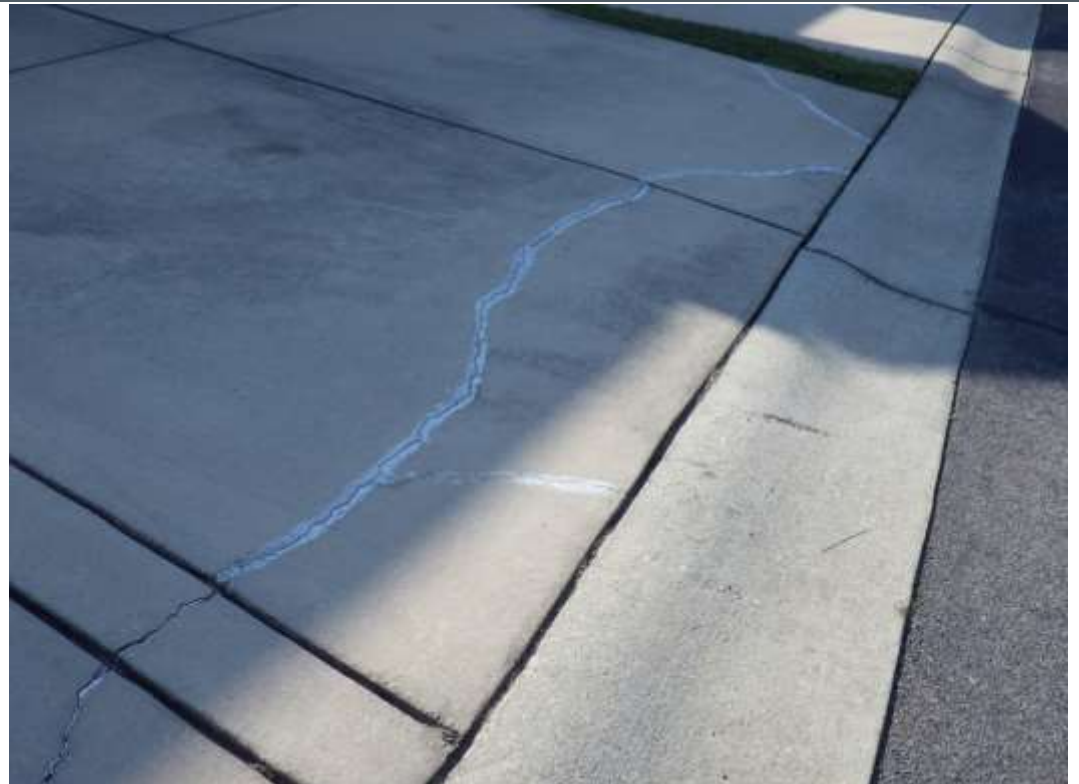
A close-up photograph of a concrete driveway. The concrete is light-colored and shows several prominent, irregular cracks that run across the surface. The cracks are deep and appear to be structural.
Cracks in concrete driveway	
Photo No. 10

Portions of severely damaged, upheaved or depressed concrete flatwork will periodically require sectional replacement to restore the condition and mitigate potential trip hazards. We have allocated funds for periodic repairs and/or replacement of the concrete flatwork as required and have assumed that approximately 2.5% of the surfaces will require maintenance every 8 years, beginning in 2028 to correspond to pavement resurfacing and concrete curbing replacement. Note that minor interim repairs may be required to address potential trip hazards as they develop, which would likely be limited to gridding across uneven joints/cracks to create a uniform surface. These limited repairs should be funded from the general operating budget when needed.

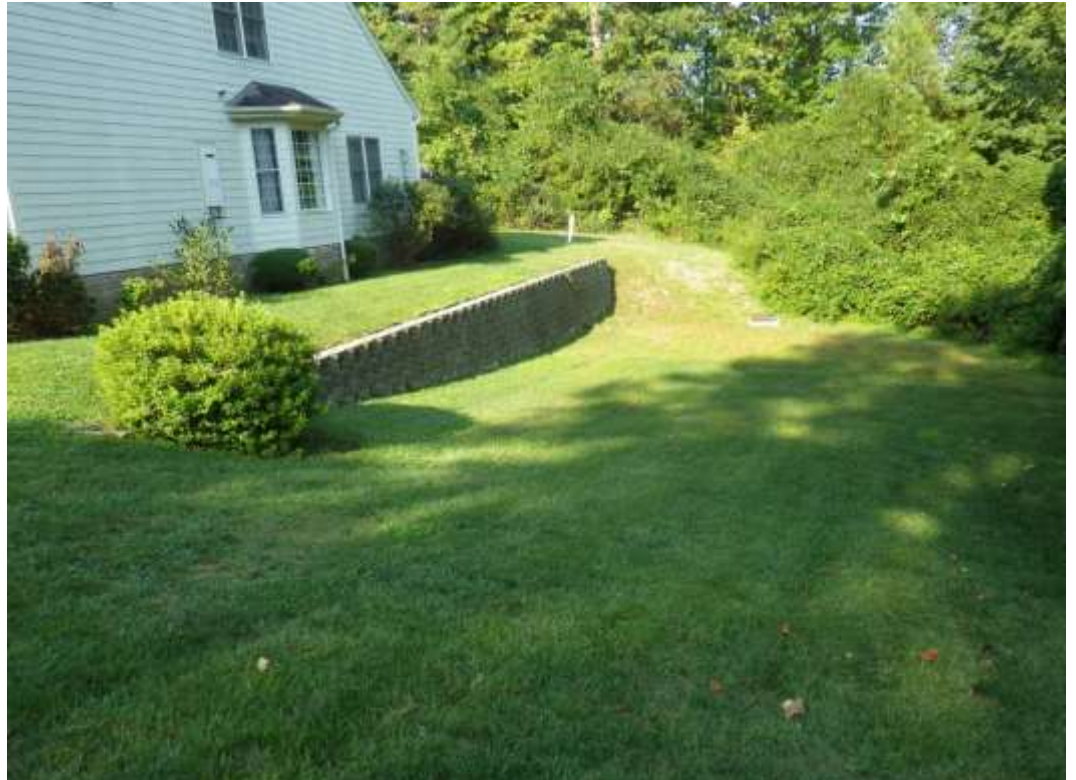
Typical common area open space with grassed ground cover and retaining wall	
Photo No. 12

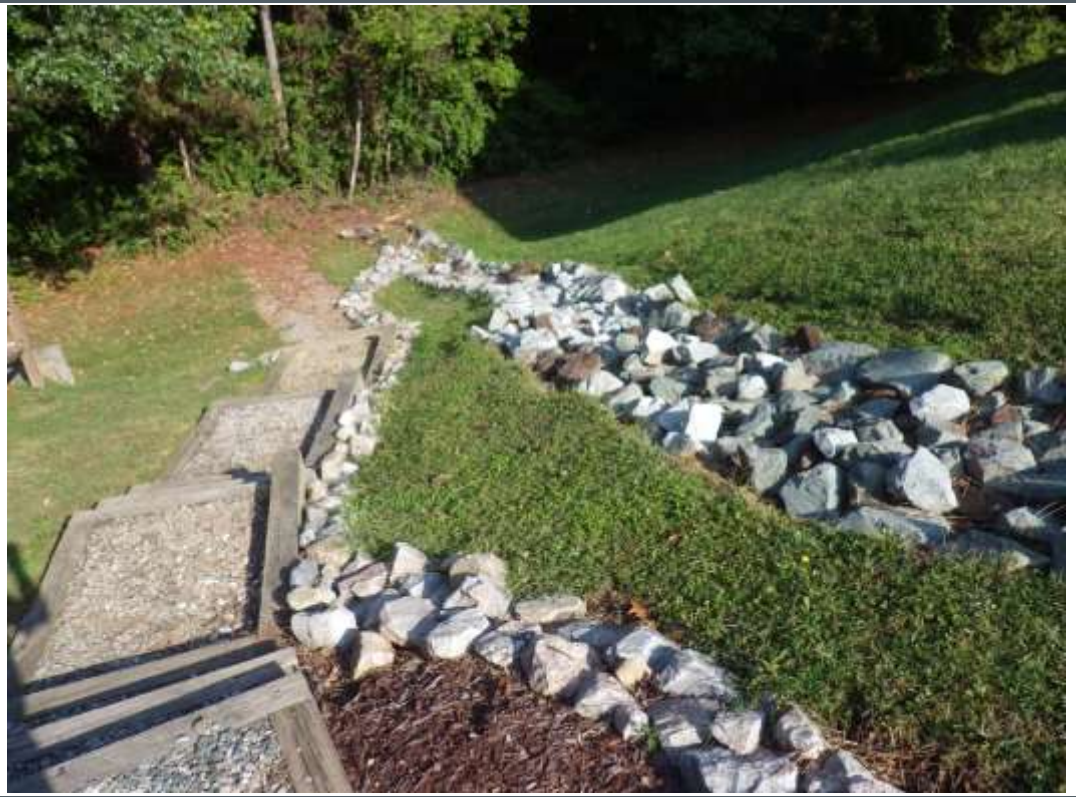
Gravel-surfaced walkways are located in limited portions of the community, which include timber steps along sloped surfaces. We observed gravel washout in multiple locations, which can likely be mitigated with new timber bordering and drainage improvements as discussed above. Gravel replenishment should be performed when needed to restore the walking surface. We have assumed that this minor task would be funded as an operational expense when needed.

Description
Gravel washout from timber stair at walking path adjacent to riprap drainage swale
Photo No. 13

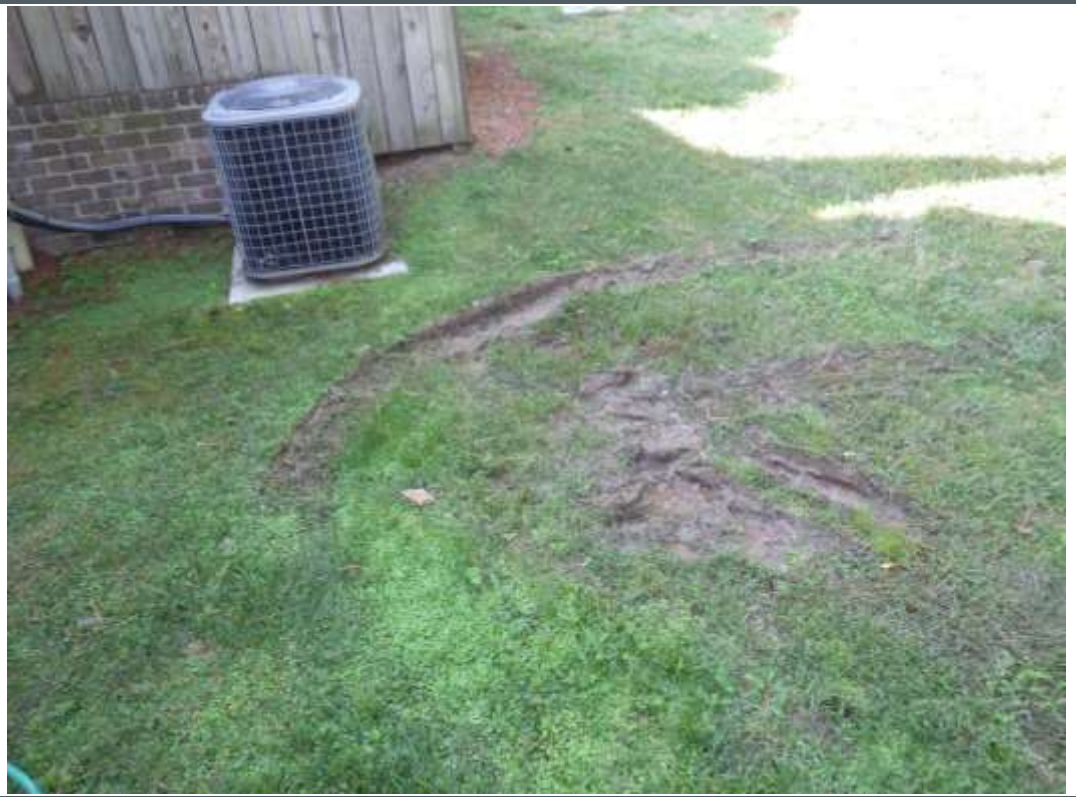
Description
Damaged ground cover and water-softened surface soils behind townhome building
Photo No. 14

We have allocated funds for repairs to the drainage systems every 5 years beginning in 2023. Initial repairs would include corrections to rippapped swales, restoration of ground cover in bare/eroded areas, surface stabilization where required, and other erosion control efforts. Future drainage repairs and improvements would likely include the installation of small landscape drainage systems to address ponding concerns in flat or low areas, re-trenching and re-armoring landscaped swales, turf replenishment or riprap stabilization in eroded areas, repairing/hydro-getting buried common area stormwater piping and other drainage system improvements. Note that the funding allowances are intended to address the highest priority areas, but are not likely suitable for drainage overhaul at each unit or in all common areas during each cycle.

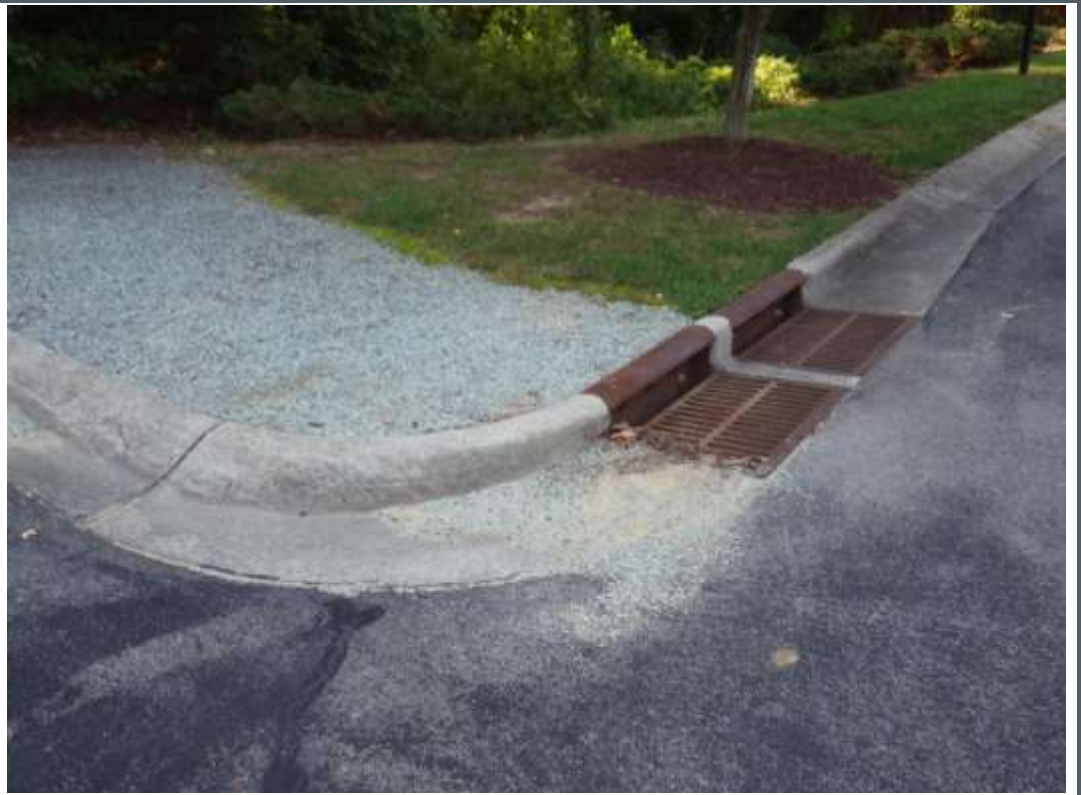
Description
Gravel washout from walking path
Photo No. 17

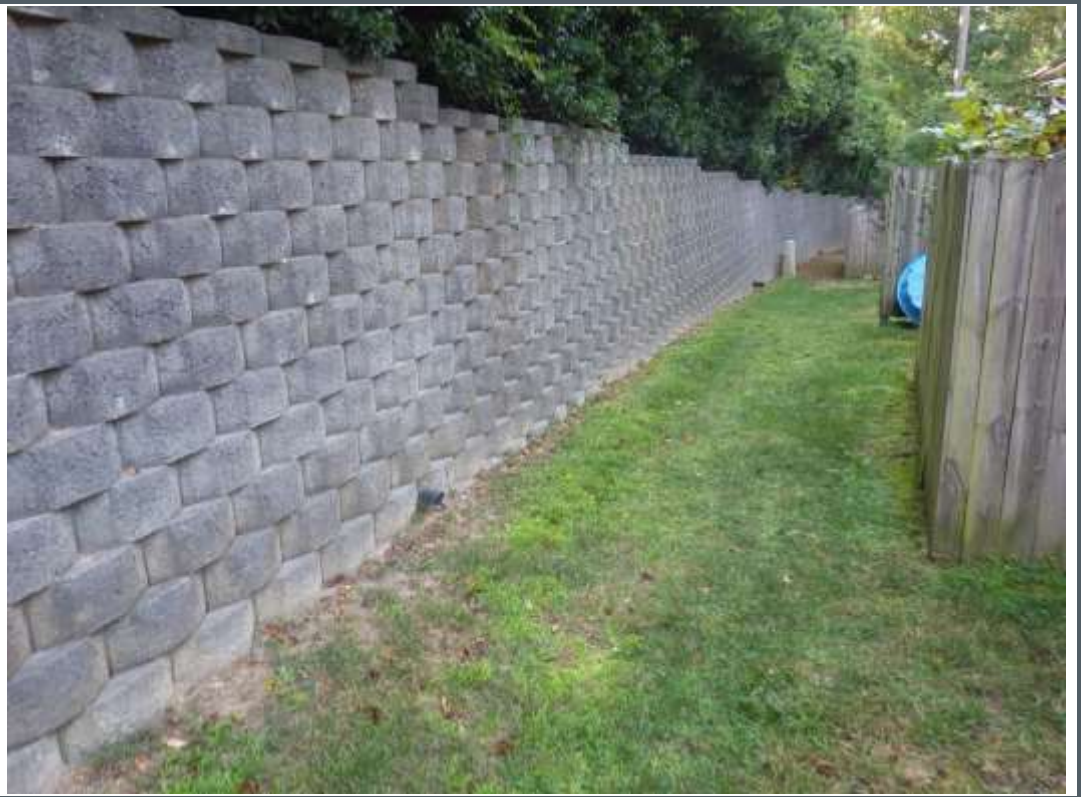
Description
Segmental block masonry retaining wall
Photo No. 18

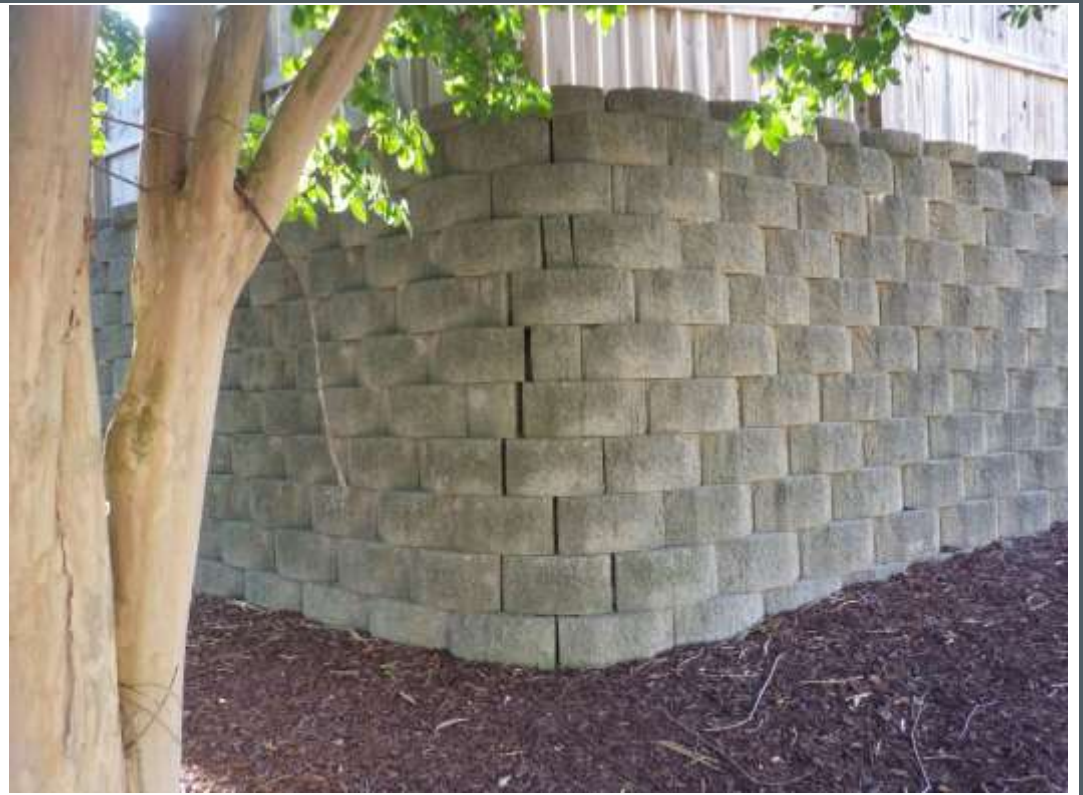
Many of the steeper topographical changes on the property are captured via segmental block masonry retaining walls. The retaining walls were in overall good to fair condition, with some evidence of minor displacement observed. The most notable example is the radius corner of the wall to the north of unit 136, with separations likely occurring as a result of the as-built construction (cut / modified blocks that do not fully interlock with the adjoining units). We recommend the Association monitor the conditions of the walls for indications of ongoing movement, noting that minor seasonal changes may occur. If these areas continue to exhibit movement or displacement, it is likely that partial reconstruction will be required.

Description
Minor separation developing at radius corner of retaining wall, north of unit 136
Photo No. 19

The retaining walls should include geo-grid reinforcement extending behind the wall with french drain type system installed behind the wall to reduce hydrostatic pressure. Assuming these systems are in place and well maintained, the retaining walls should typically have an expected useful life well beyond the term of this study (40+ years); however, considering the evidence of previous displacement, we recommend budgeting for partial reconstruction as a moderate-term expense. We have included funds in 2033 for retaining wall repairs.

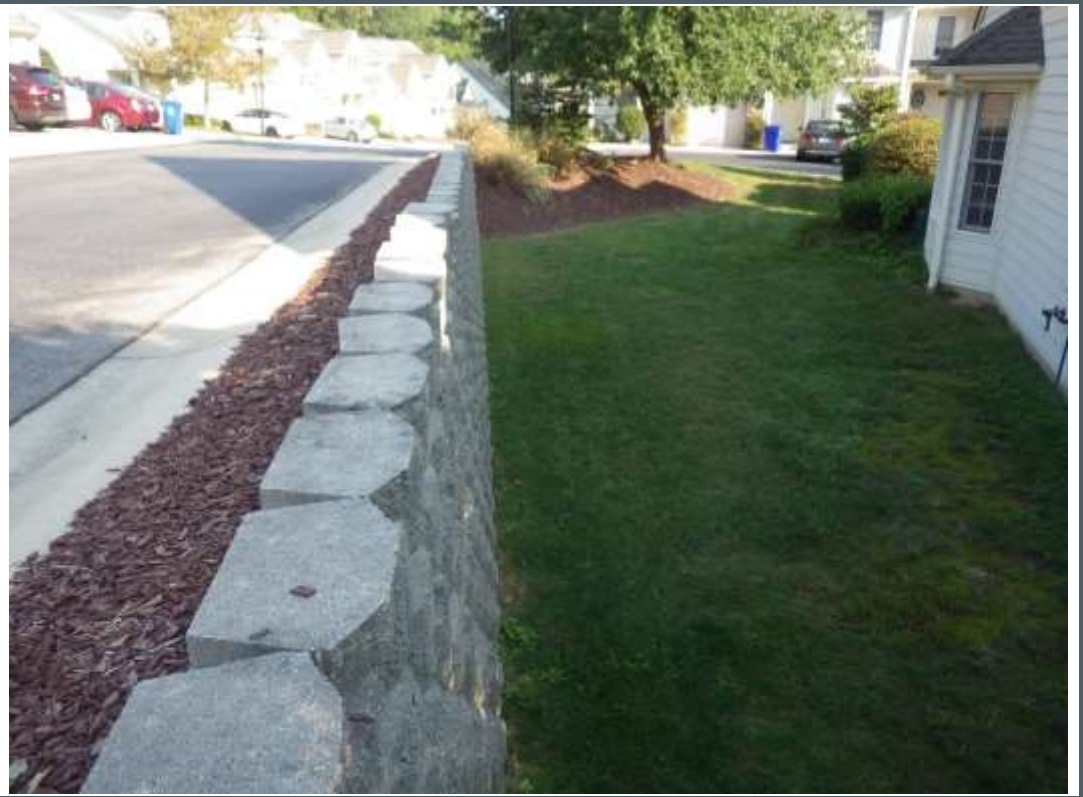
Description
Retaining wall east of unit 114, with no fall protection fencing adjacent to street
Photo No. 20

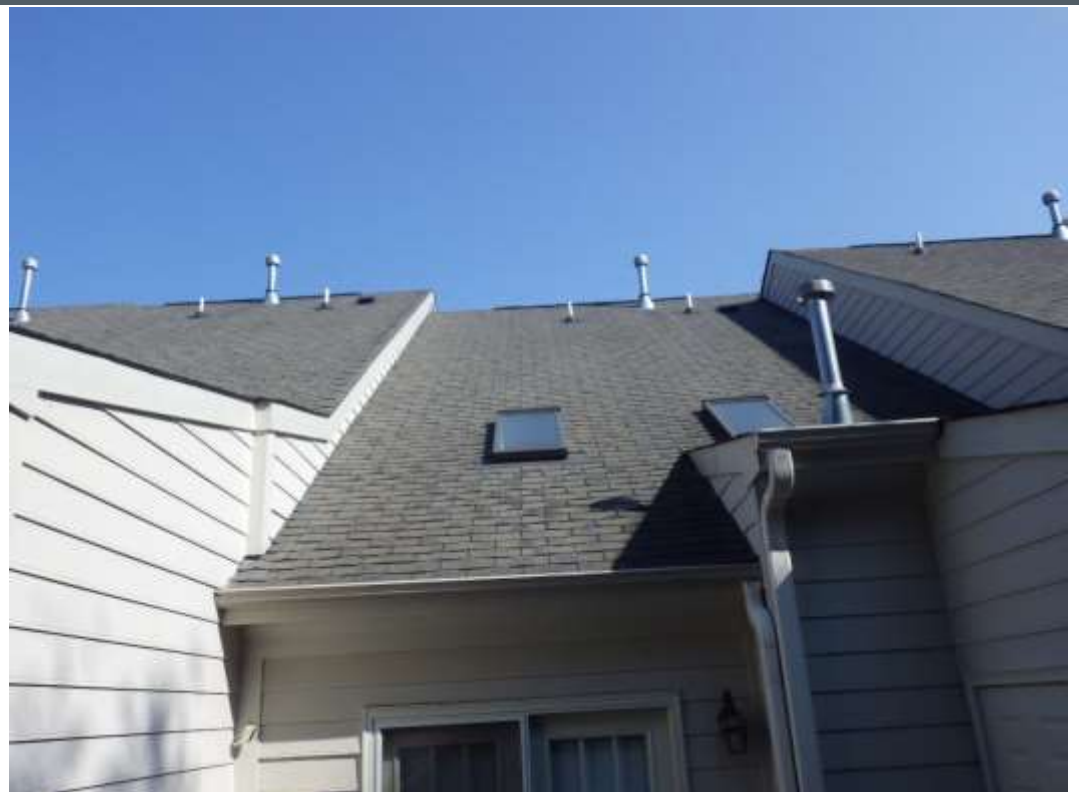
Roof shingles	
Photo No. 31

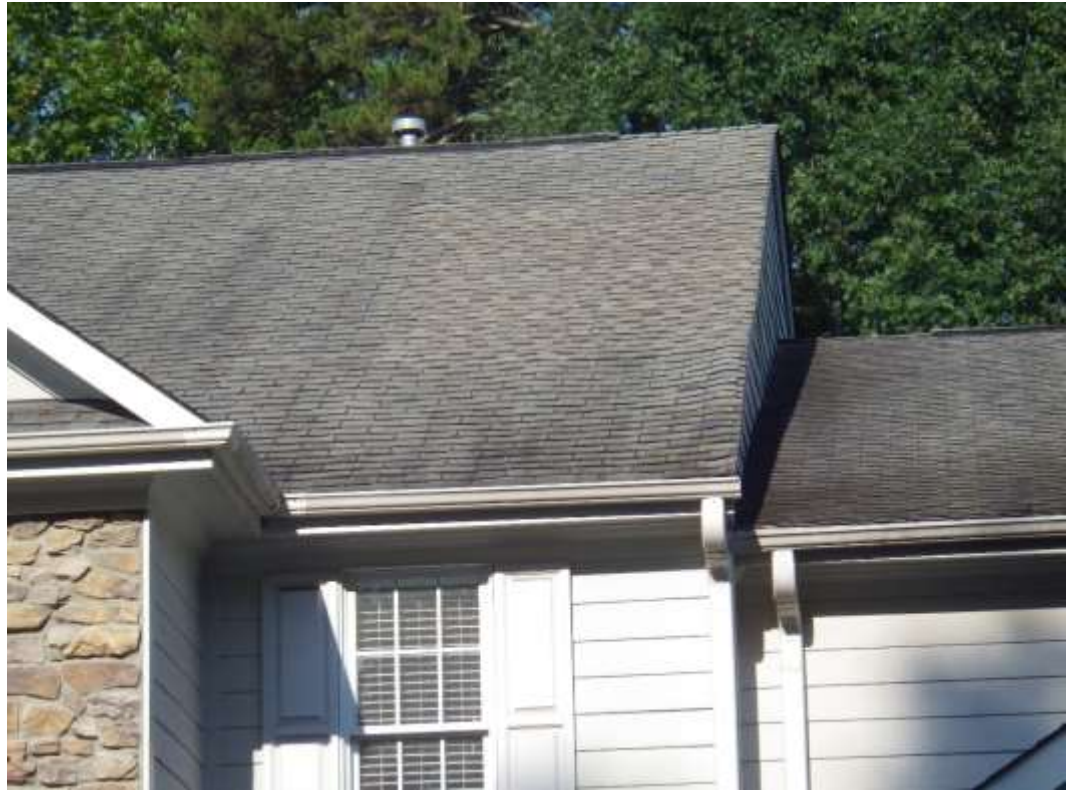
The building roofs are clad in asphaltic fiberglass decorative three-tab shingles. Gutters and downspouts are installed, and discharge stormwater to grade. The roofs are majority original to construction, and we noted several areas of previous repairs. We understand the Association has identified six building roofs which will be replaced in 2023, and the remaining three buildings replaced in 2024. We have included funds for roof replacement in two phases to match this schedule.

Description
Previous roof repair
Photo No. 33

We strongly recommend that any re-roofing project closely follow procedures outlined by the National Roofing Contractors Association's *Roofing and Waterproofing Manual*. A re-roofing sequence should include removal of the existing roofing material, replacement of any inadequate roof sheathing, replacement of any damaged flashing, and replacement of drip edge components. Periodic minor repairs to the vent boots, flashing and gutters will likely be required in the interim, prior to full roof replacement. Minor repairs to correct roof leaks may also be required on an annual basis. We have assumed these types of minor repairs would be funded from the annual maintenance budget as needed.

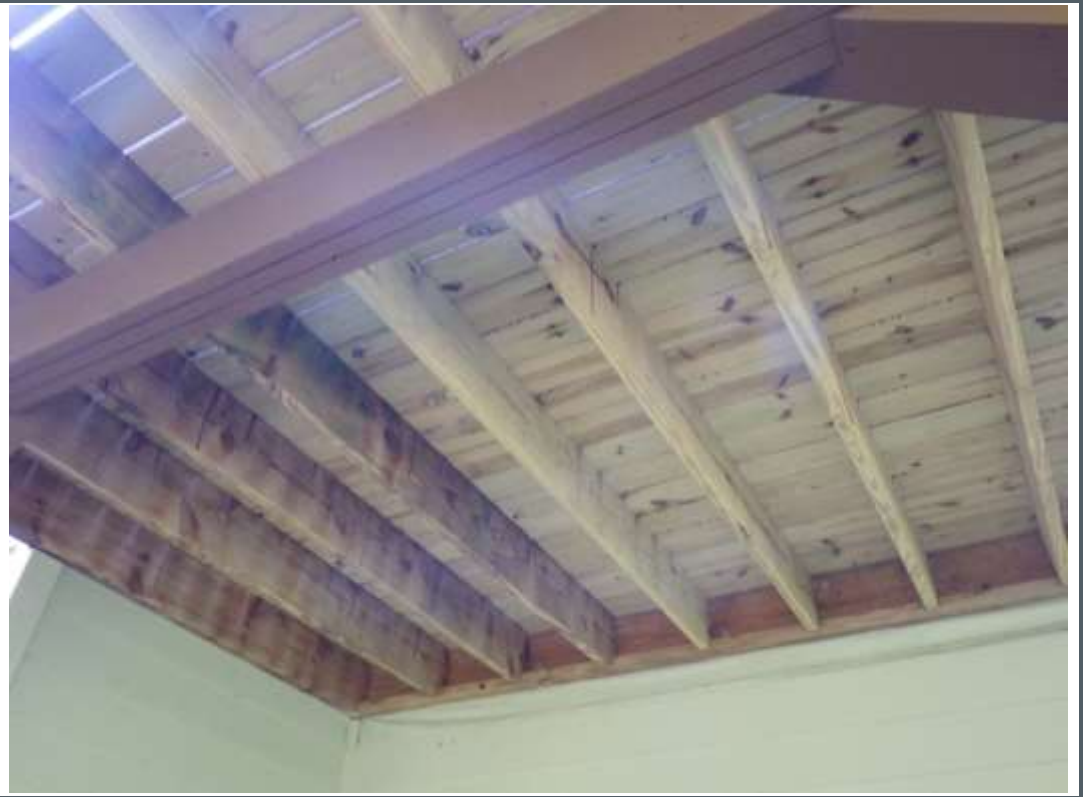
Wood-framed deck structures are installed at the rears of the townhome units 153-163 and 167-177, which are the responsibility of the Association. The decks have been recently repaired, and stained, and the framing appeared to be in good condition. Due to the location of the decks with proximity to tree cover and in shaded areas, staining will likely be required on an approximate 3- to 5-year schedule. We have included funds for

Description
Rear decks have been recently repaired
Photo No. 35

future staining/sealing the decks on a 4-year schedule beginning in 2026. Re-staining may not be required at this frequent interval, and it may benefit the Association to extend the cycle if the stain coat remains in adequate condition at year 3. We have also included funds for a future large-scale replacement project in 2037, which will likely be a similar scope to the recent project.

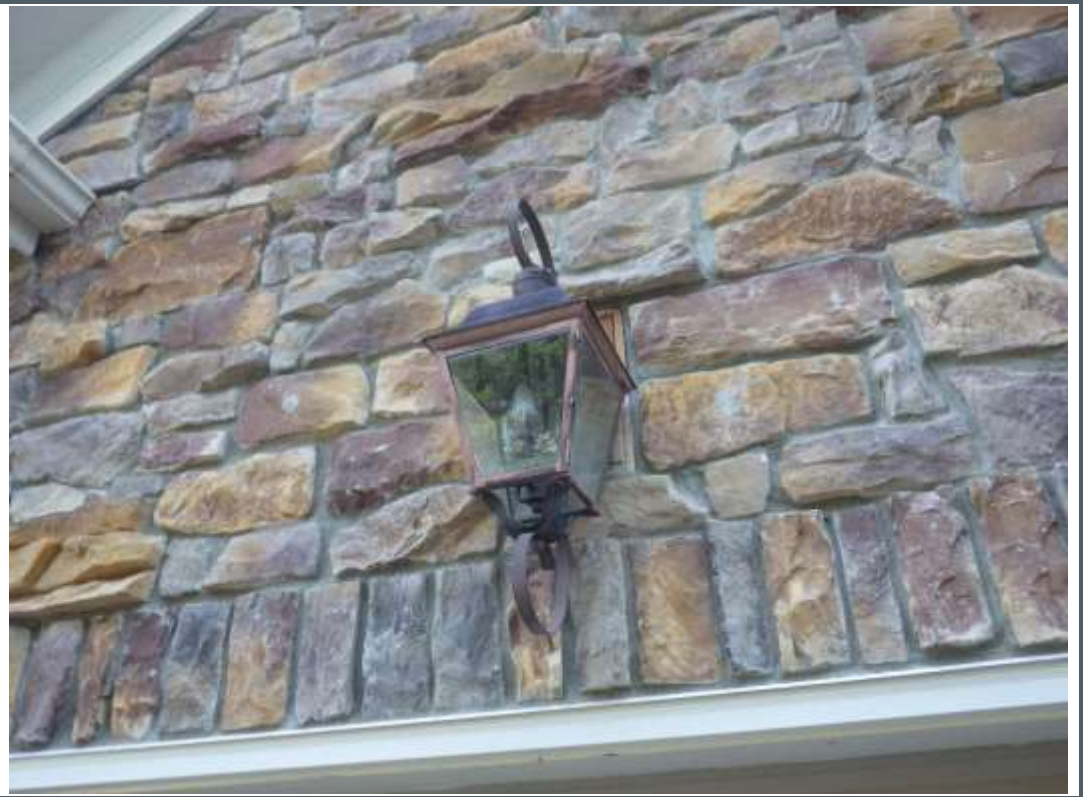
Lantern-style light fixtures are installed above the garage doors, and adjacent to the doors at the rear patios and decks at each unit. The fixtures were showing signs of age, and we understand the Association wishes to begin replacing. We have included funds to replace the light fixtures between 2024-2026, approximately 1/3 of the units each year.

Description
Exterior light fixtures at townhome buildings
Photo No. 36
